**IN THE HIGH COURT OF SOUTH AFRICA  
WESTERN CAPE DIVISION, CAPE TOWN  
(Exercising its Admiralty Jurisdiction)**

Case number: AC 78/2008

**Name of Ship: MT “BOW SUN”**

**JUDGMENT**

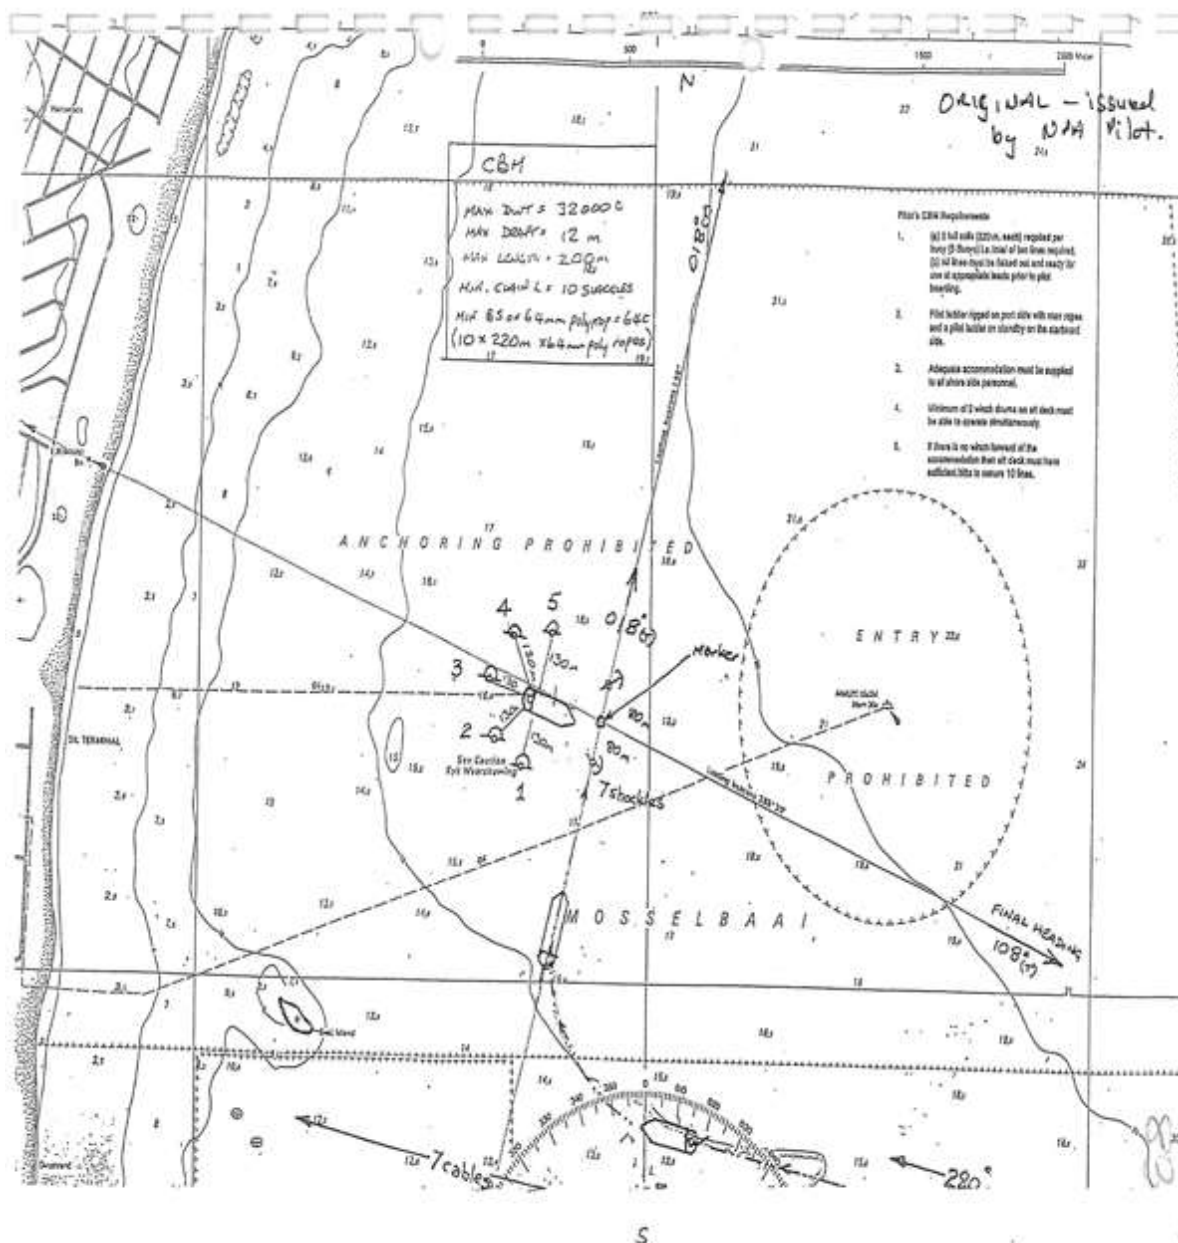
The SPM terminal is in the middle of the circular area labelled 'ENTRY PROHIBITED'. The dotted line leading from left to right to the terminal point at the SPM represents the route of the SPM pipeline from the shoreline, which is indicated by the speckled swathe on the left hand margin of the diagram. (The handwritten information in the box headed 'CBM', which might be difficult to read in the reproduction above provides as follows: 'Max DWT = 32 000 t, Max draft = 12 m., Max length = 200 m., Min chain L = 10 shackles, Min BS of 64 mm polyprop = [?] 64t, 10 x 220 m x 64 mm polyropes'.)

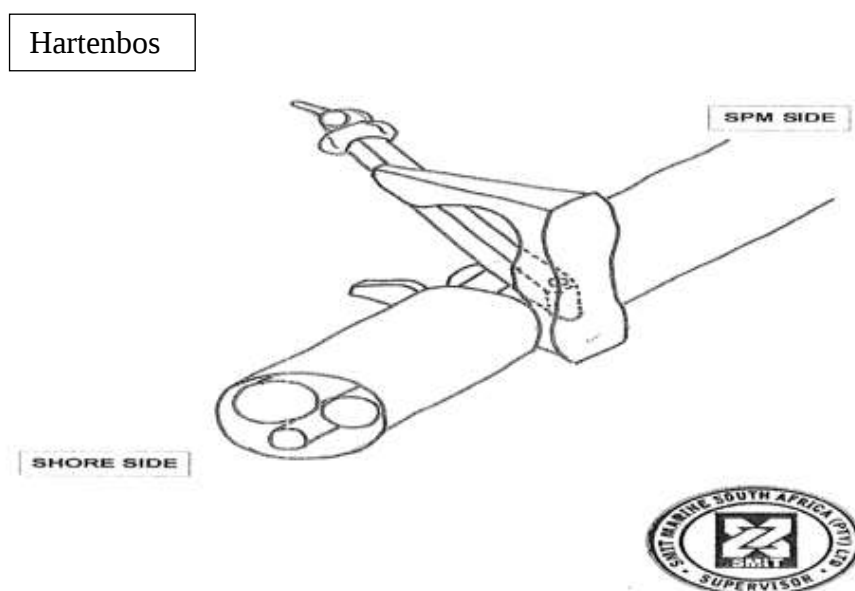
[89] Mr de Wet observed that the carrier line casing had broken across its entire circumference (i.e. what the plaintiff's counsel referred to in their heads of argument as 'a 360° split'). On the upper section of the line the break was a clean one, almost as if the casing had come apart at a welded join in the metal,<sup>42</sup> whereas in the lower section the character of the break was jagged. De Wet noted that the product lines within the carrier line had been '*all bundled up together, held together by the anchor and sort of up and to the Hartenbos side*'.

[90] De Wet, who was very familiar with the pipeline by virtue of being involved in regular maintenance inspections along its length, also remarked that ‘*there [were] quite a lot of sort of scrape marks – scratch marks, a number of dents on both sides of the carrier [were] very clearly visible*’. De Wet subsequently made a drawing of the observed position of the anchor relative to the carrier line. He explained that the drawing was not intended to depict the actual position of the product lines at the time, which was something that he was not concerned with at that stage. It is also not to scale nor intended to be technical drawing. De Wet described it as ‘an artist’s rendition’. A copy of the drawing is reproduced below (I have inserted a text box to indicate ‘the Hartenbos side’):
